KB5TX Repeater site

Quick Tour of site and Winter Storm Damage

Third week of February 2021

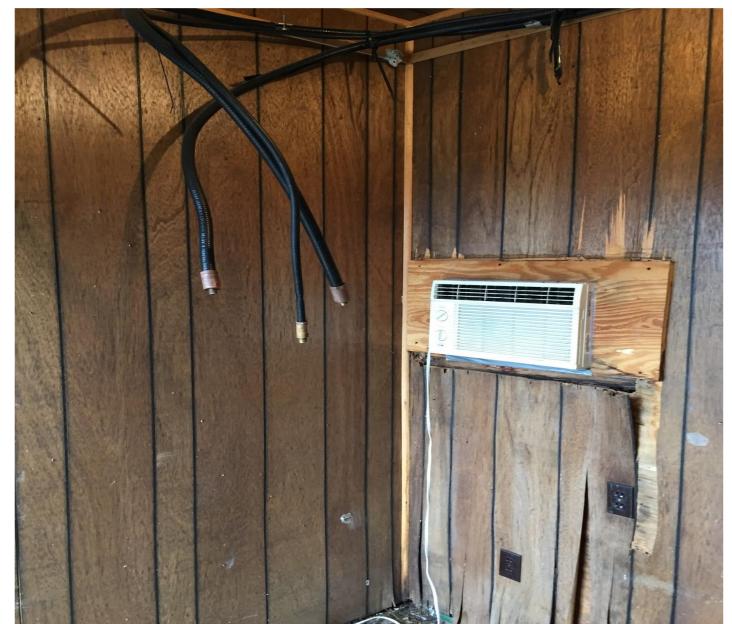
Rotted Paneling from Water Intrusion

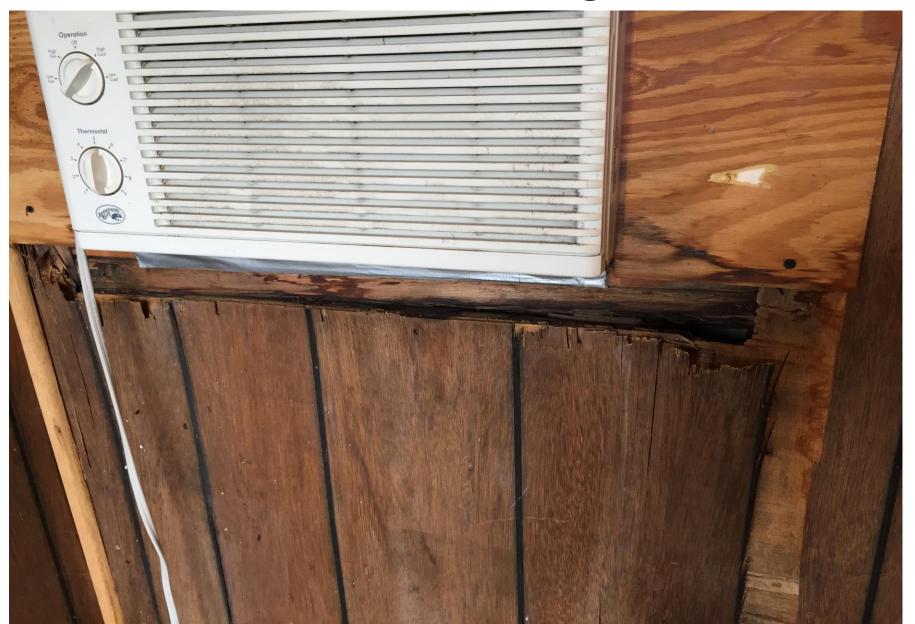
Rotted Paneling

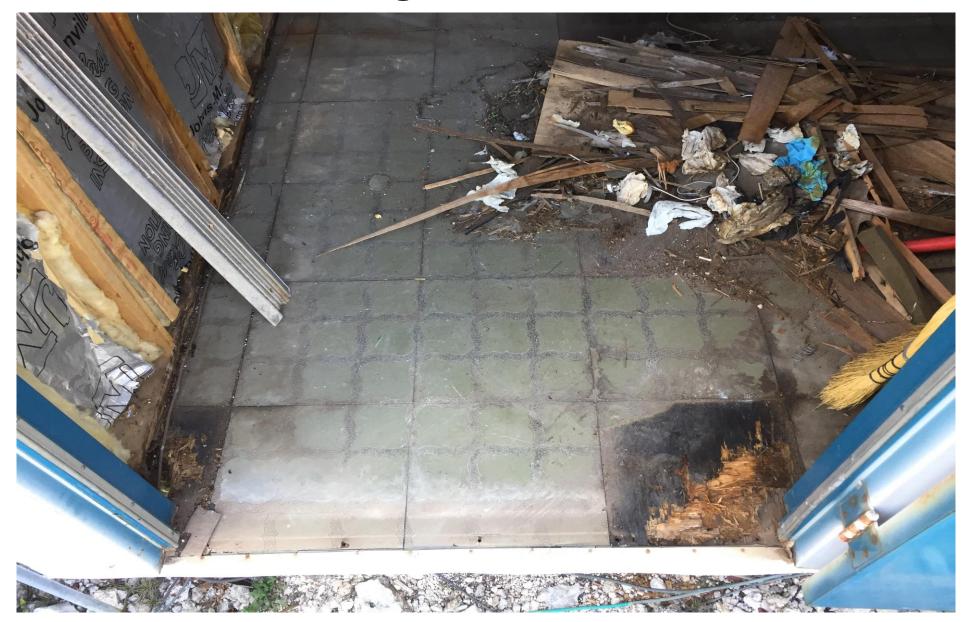
Floor Rotting at Door Threshold

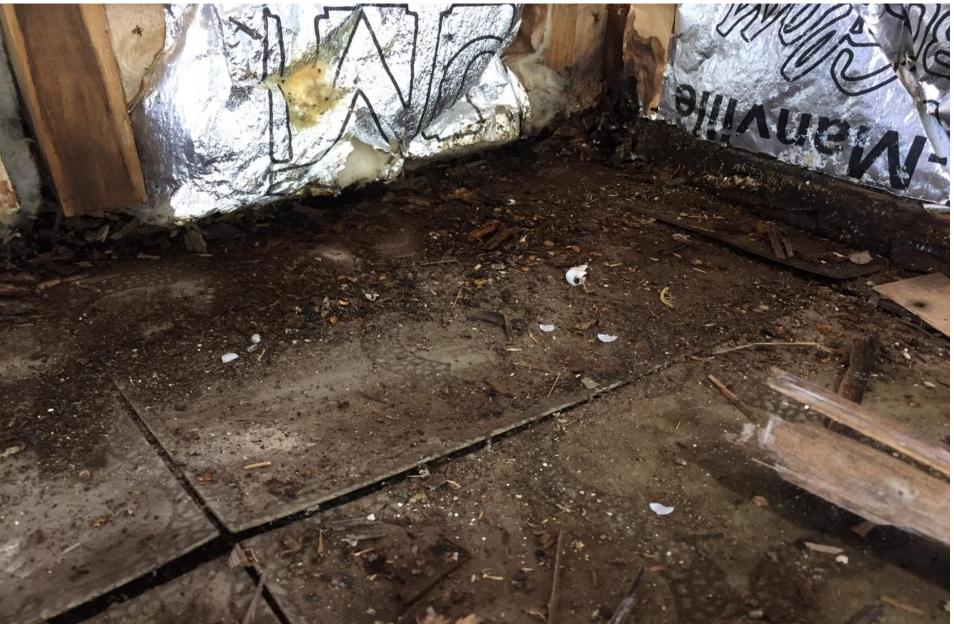
Sole Plate or What Sole Plate?

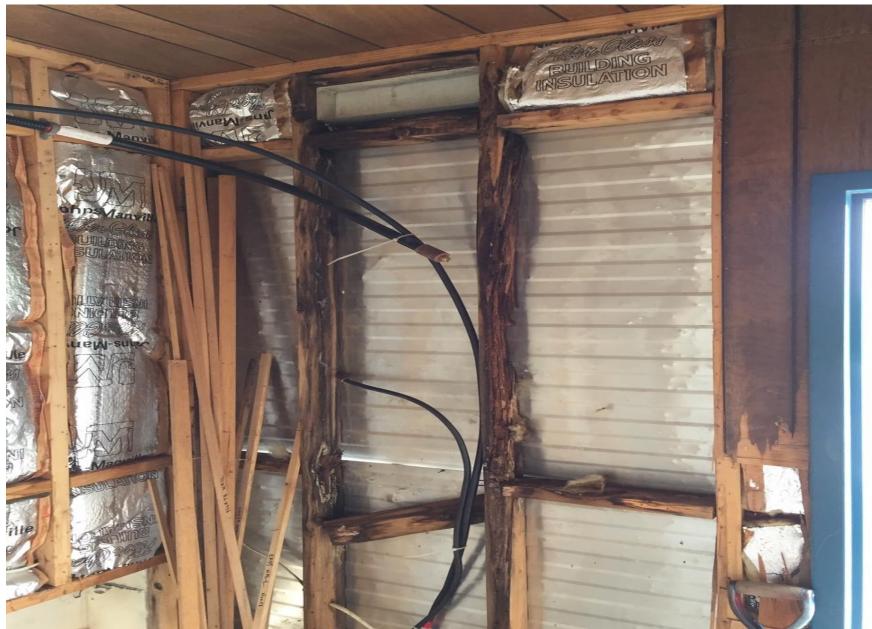
Rotten Studs from Water

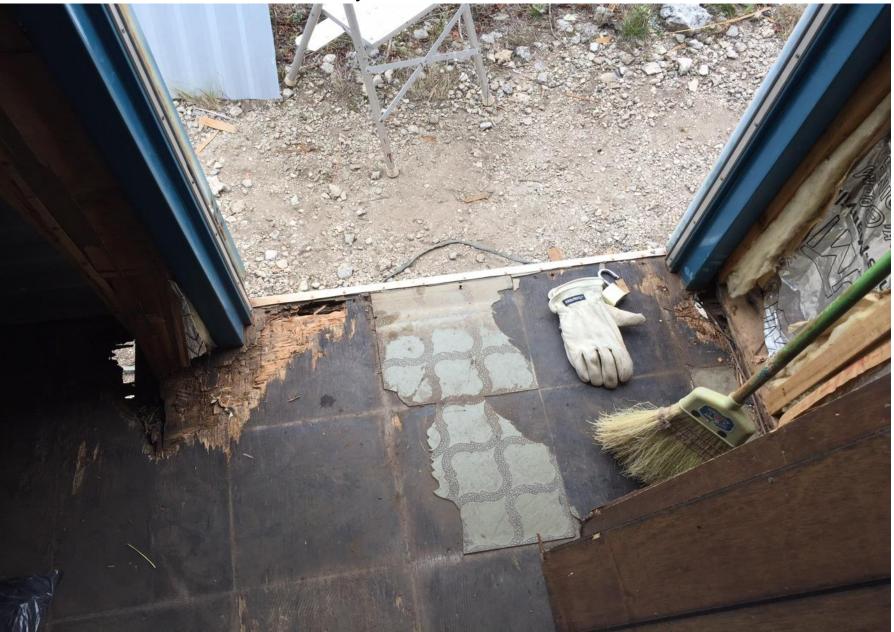
Doorway Threshold Rot

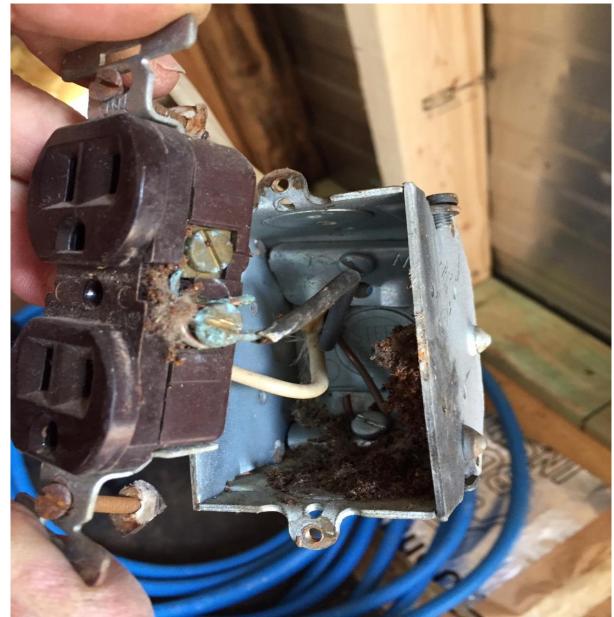
Corroded Electric Connections

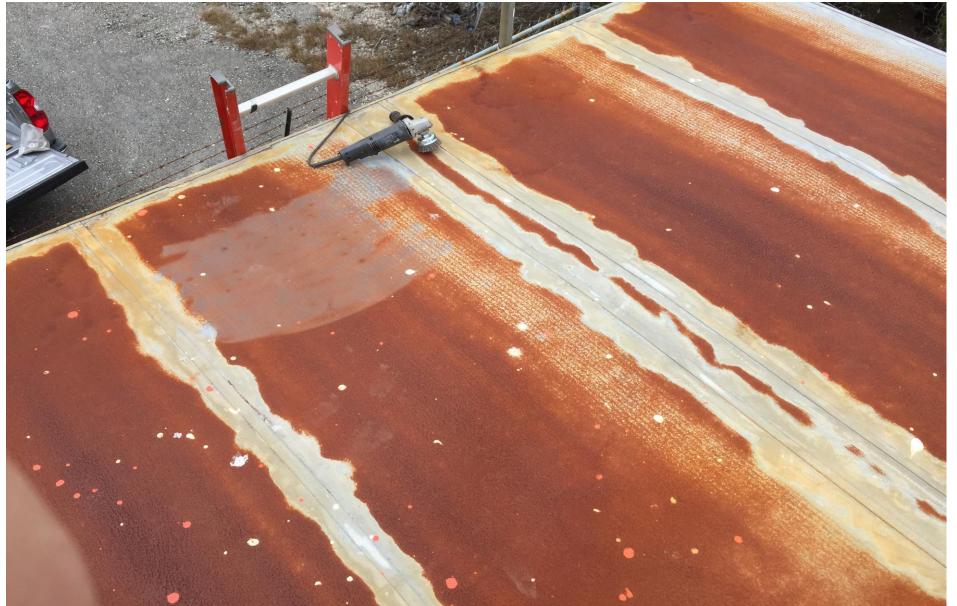
Roof Condition

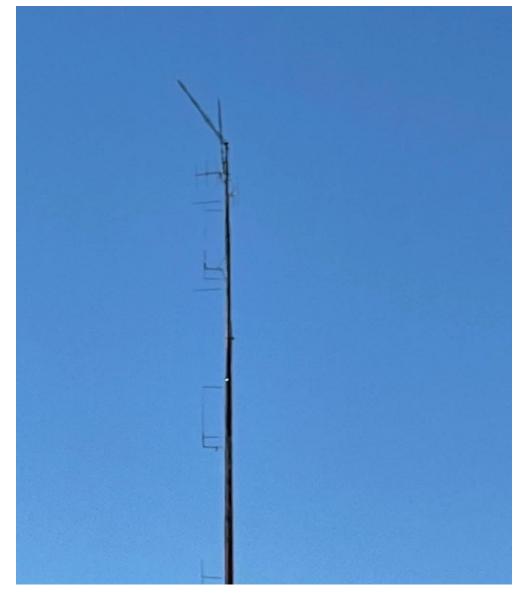
Damage at Repeater Site View up Tower

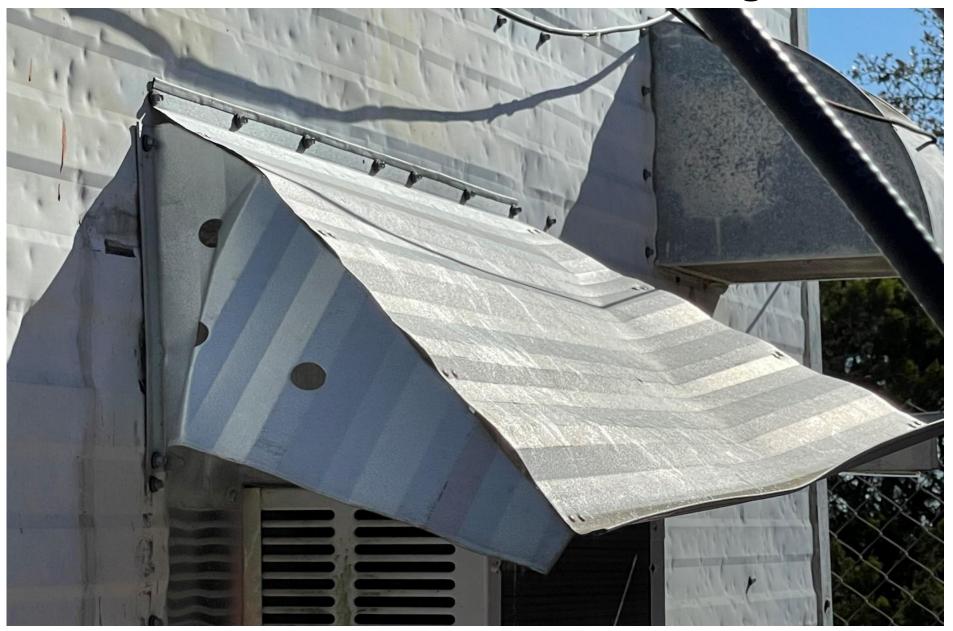
Side View From Ice Damage
